# Scanning Electron Microscopy in Failure Analysis and Accident Investigations

**M.A. Venkataswamy**

National Aerospace Laboratories, Council of Scientific and Industrial Research (CSIR), Bangalore-560017, INDIA  
E-mail: swamy@nal.res.in

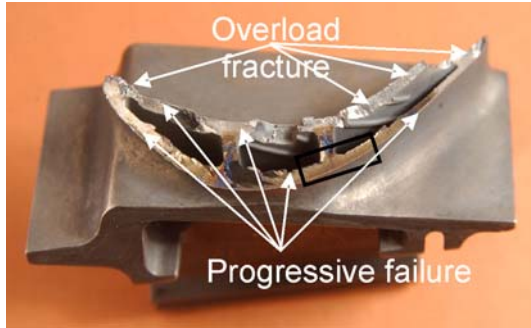
The failure occurred during test run of the engine and resulted in damaging various components of the engine. The fractured blades were examined under stereo binocular microscope (Fig. 1) and SEM for identifying the fracture features. The fractography showed that the blade had failed by fatigue (Fig. 2a and

**Fig. 1:** Fracture Surface of the LPTR Blade of Aero Engine

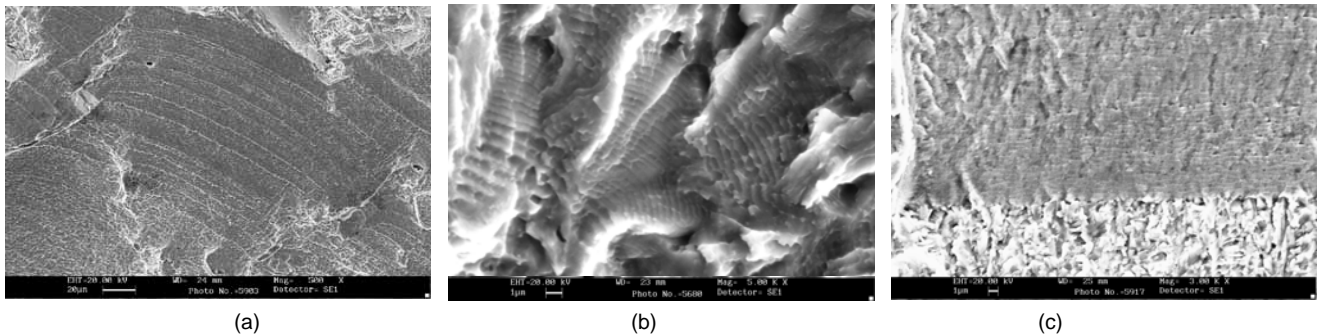
Fig. 2b). The fatigue cracks initiated on the convex surface of the airfoil propagated progressively over about 80% of the blade cross-section and finally failed by over load fracture.

Examination revealed that the fatigue cracks had initiated in platinum aluminide coating on the blade aerofoil (Fig. 2c). Number of cracks was found in the coating surface and one of these cracks had subsequently propagated by fatigue leading to the fracture of the blade. Analysis revealed that the blade undergone

excessive bending which has resulted in generation of fatigue cracks on the airfoil surface close to the root.

**Fig. 2:** SEM Fractograph of (a) Crack Arrest Marks Typical of Progressive Failure, (b) Fatigue Striations, (c) Fatigue Striations Parallel to the Coating-Blade Material Interface

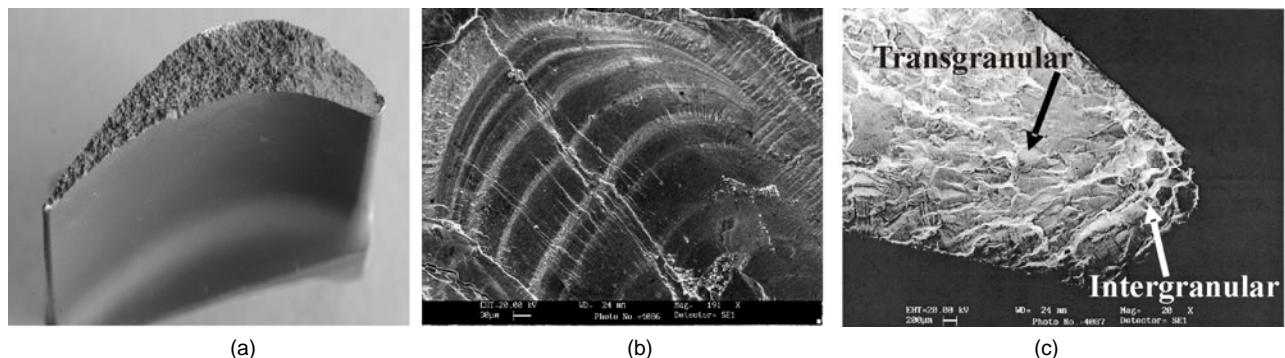
Aircraft met with an accident during flying. After detailed investigation of LPTR blades, HPTR blades, Low-pressure nozzle guide vanes, high pressure nozzle guide vanes and portion of hydraulic reservoir parts, one of the LPTR blades (Fig. 3a) had failed by fatigue and all other blades and vanes failed by over load. Fractography revealed that, the fracture had initiated at the leading edge and showed the presence of faceted fracture features. SEM fractographs showed well-defined beach marks typical of fatigue (Fig. 3b). Higher magnification images clearly revealed that the crack had initiated initially by intergranular and later propagated by fatigue (Fig. 3c). The reason for intergranular crack propagation is due to high operating temperature and high stresses on blade surface. Hence stress rupture has taken place at the leading edge and later propagated by fatigue before culminating in over load failure.

**Fig. 3:** (a) Fracture Surface of Failed Blade, (b) Crack Arrest Marks Typical of Progressive Failure, (c) Intergranular and Transgranular Fracture Features

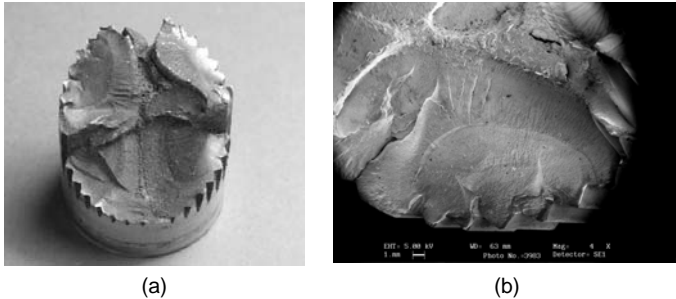
The investigation team received two service failed components namely a rotor shaft and an input shaft of power steering gears. The shaft had fractured in the splined root region in a spiral fashion. Examination revealed that four fatigue cracks (Fig. 4a) initiated on the shaft at approximately 90 degree to each other and propagated simultaneously over about 90% of the cross section before giving way to final over load fracture.

**Fig. 4:** (a) Fracture Surface Showing Multiple Crack Origin, (b) Beach Marks Typical of Fatigue Failure

Figure 4b shows beach marks typical of fatigue originated at the spline root region propagated towards the centre of the shaft. The fatigue appears to be a high cycle—low stress type. The reason for fatigue crack initiation at the spline root region is due to less root radius. The negligible root radius might have given rise to stress concentration which facilitated to initiate fatigue crack. No metallurgical abnormality was responsible for the fatigue initiation.

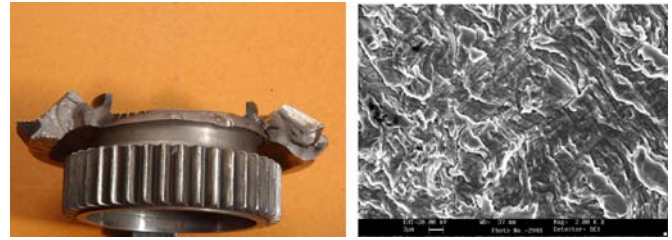
The failure occurred during endurance testing of an engine. As per the report the failed gear box is a modified one. The bevel gear and spur gear were joined together by electron beam welding to form an integral part (Fig. 5a). Detailed examination revealed that, the fatigue crack (Fig. 5b) initiated at the weld joint and propagated across the bevel gear. Cracks were also observed at the spline root regions. Change in microstructure and hardness variation in the weld, bevel gear and spur gear assembly clearly indicates the residual stress concentration was very high at the weld region. This has caused to initiate fatigue crack at the weld region.

**Fig. 5:** (a) Photograph Showing Failed Component, (b) Fatigue Striations
